# Manhole Inspection Summary

Manhole # S37II\_016MH

Insp Date: **3/16/07 7:53 AM**

**Location** Address: **462 FEDERAL ST**

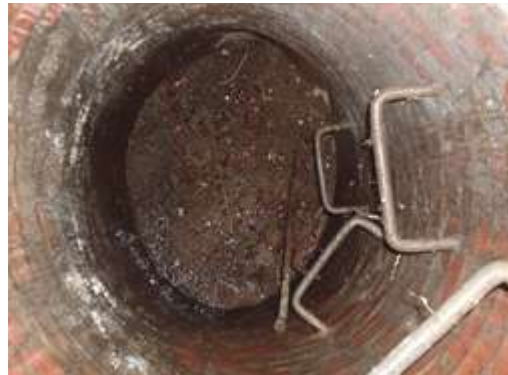
Top View

Corroded steps. Channel debris.

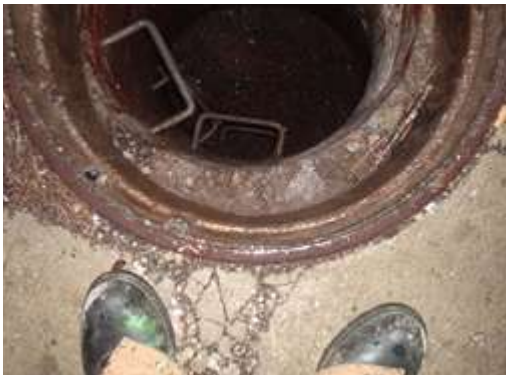
Defect

Frame leaks. Frame offset.

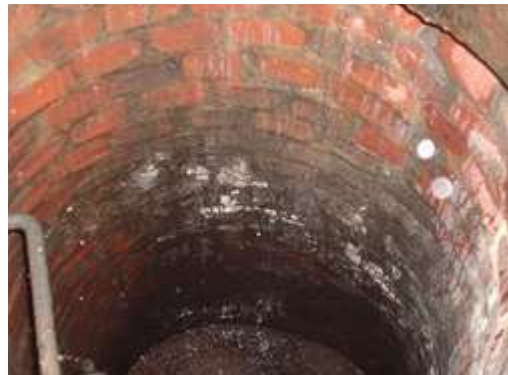
Defect

Corbel and Barrel infiltration.

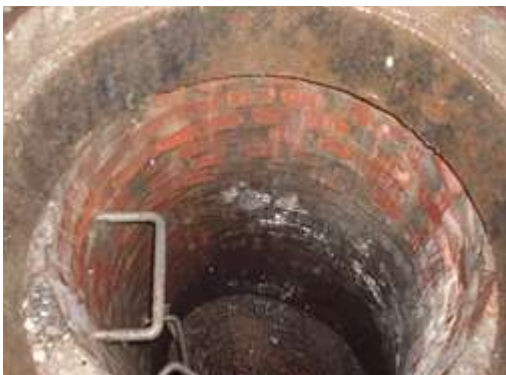
Defect

Frame offset. Adjustment deterioration and infiltration. Corbel and Barrel infiltration.

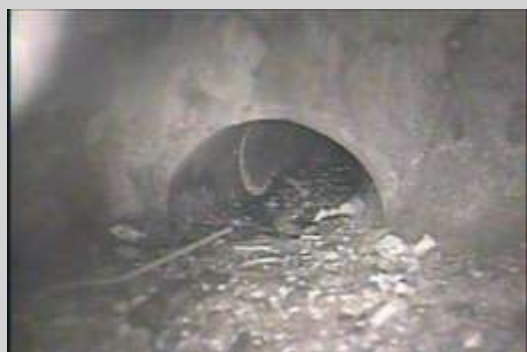
Pipe Out @ 12 O'Clock

Deposits: ☐ None ☒ **Mud** ☐ Sludge ☒ **Debris** ☐ Grease

Pipe Seal Cond: **Broken**
